CROSBY MANSION
Crosby Road, Brewster, MA
Sheet 2 of 3 Sheets

**Structural Betterments
Along Exterior Veranda
Crosby Mansion**

DATE: 10/28/06 DRAWN BY: JDB CHECKED BY: CCH (PROJ. NO. 06010)
SCALE: AS NOTED

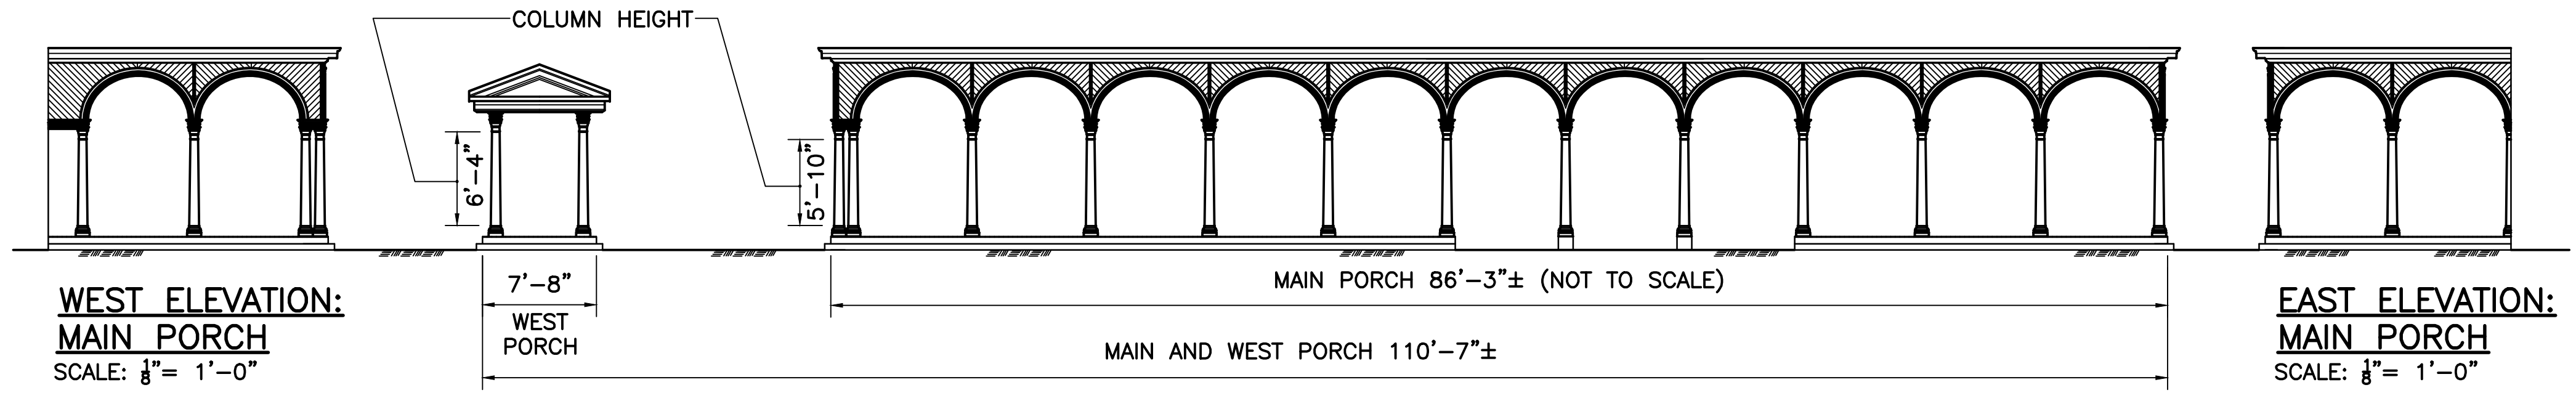
**WEST ELEVATION:
MAIN PORCH**
SCALE: $\frac{1}{8}'' = 1'-0''$

SOUTH ELEVATION: PORCHES
SCALE: $\frac{1}{8}'' = 1'-0''$

**EAST ELEVATION:
MAIN PORCH**
SCALE: $\frac{1}{8}'' = 1'-0''$
